Report of a Provincial Officer

**Air Quality Impacts of Unimin Ltd. on Kasshabog Lake
near the Town of Havelock, Ontario**

February 15, 2013

Michael Ladouceur
Air Scientist
Provincial Officer 143
Air, Pesticides, Environmental Planning Unit
Technical Support Section
Eastern Region
Ministry of the Environment

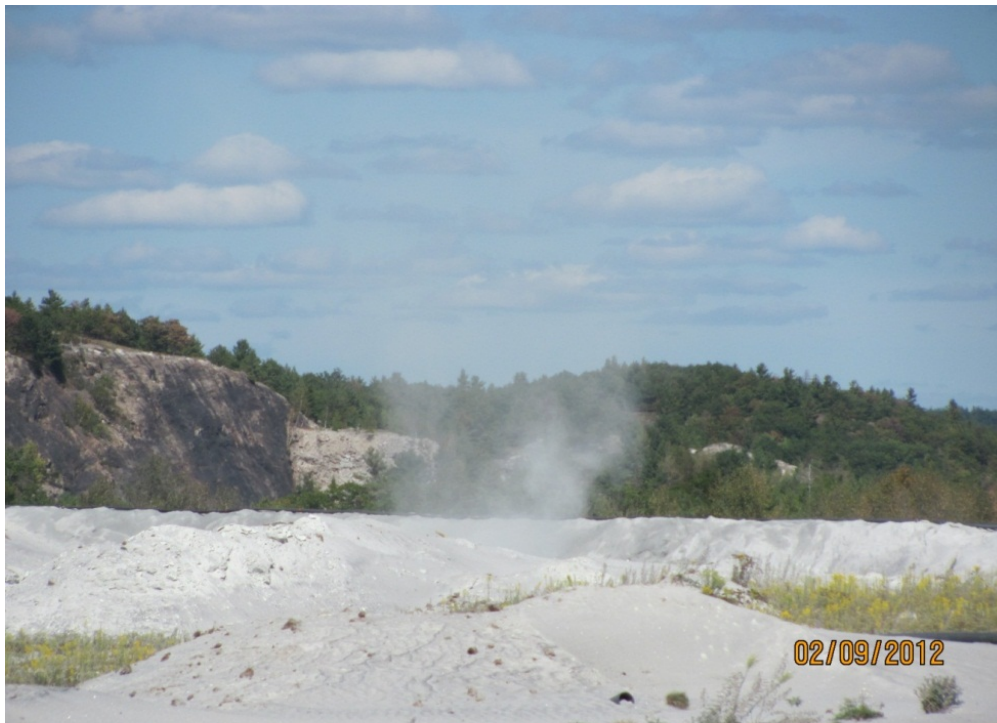
Figure 3: Particulate Vortex

The passage of winds from the west must travel around the elevated topography near the site. This causes the wind to accelerate and generates turbulence that is effective at lifting dusts and particulate. This has been observed by provincial officers.

Figure 3 is a photograph taken by a Provincial Officer during a site visit. Please note the localized character of the event. The material in tailing piles is being vigorously lifted and is available to be transported.

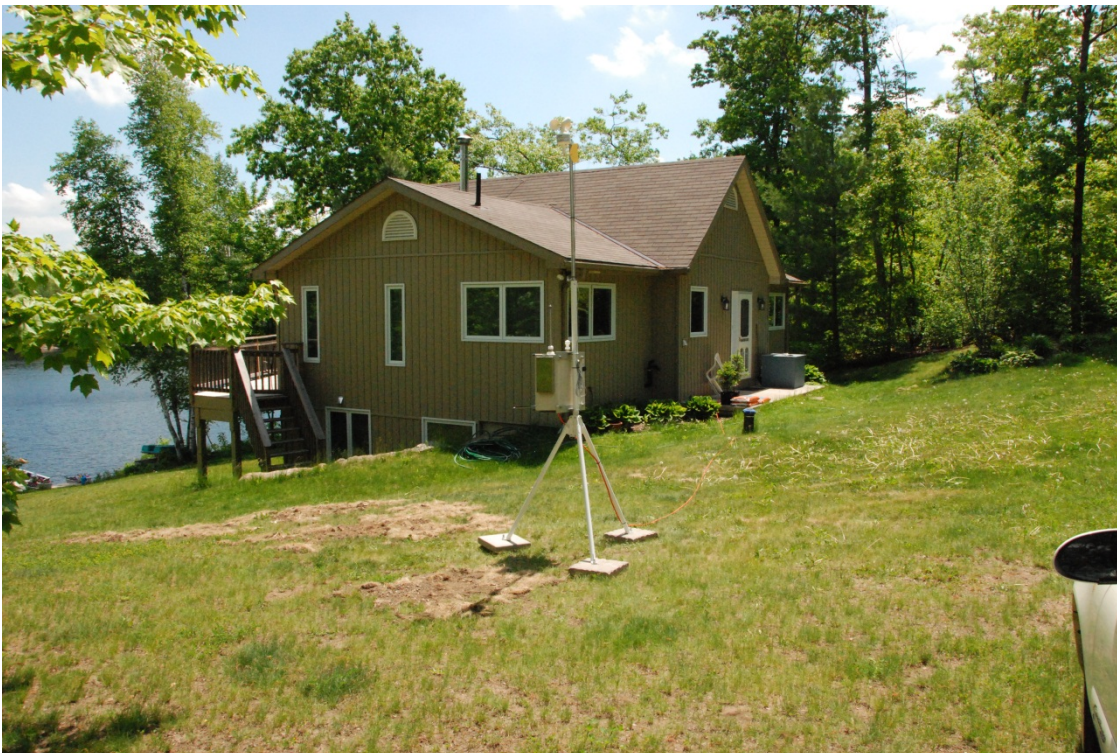
Figure 13: B1 Station

The following photographs depict the GRIMM samplers and their deployment. The original intent of this survey was to collect data to confirm and quantify particulate soiling complaints reported to the Ministry. The samplers were placed on complainants properties to assess their personal exposures to particulate. This required siting the devices in locations that do not meet the rigorous siting requirements of typical air quality studies. Consequently the data is treated more generally than normal in context of “source-receptor geometry”. The effects of terrain and turbulence will be discussed in subsequent sections.

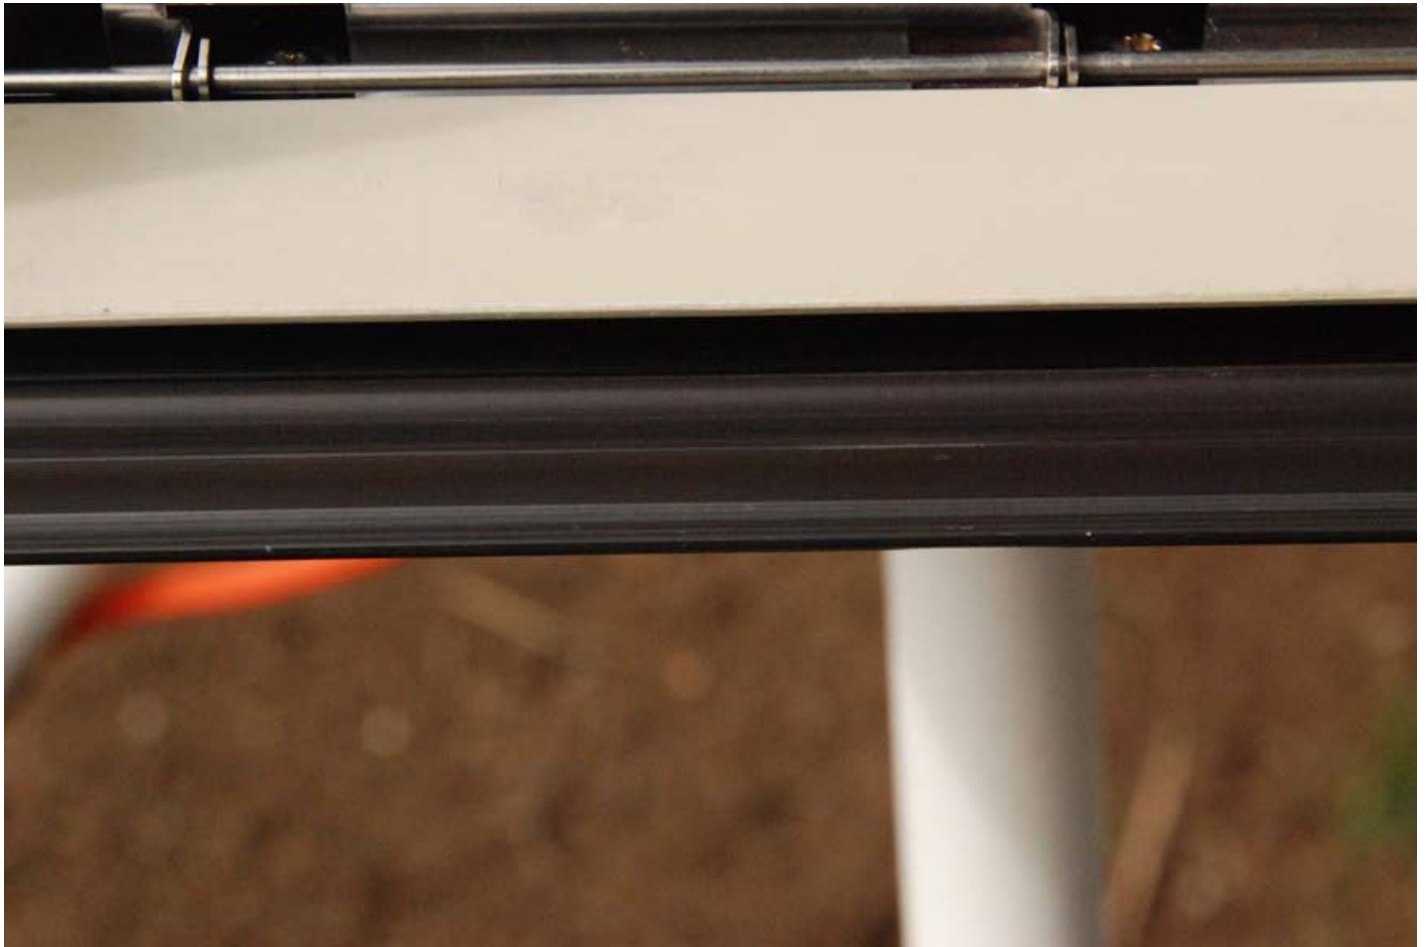
Figure 5: GRIMM sampler- cleaned

Officer Burt collected samples of dust which accumulated on the sampling equipment housing upon several occasions. These samples were sent for microscopic examination and analysis. The photographs below were taken by Officer Burt, and are fully described in his report.

Detailed microscopic examinations of tailings dust and Unimin product were undertaken. Details of size fraction composition were produced. Those analytical reports are appended in Officer Burt's report. The MOE GRIMM sampling units will not detect these larger fractions, but their deposition effects can be noted.

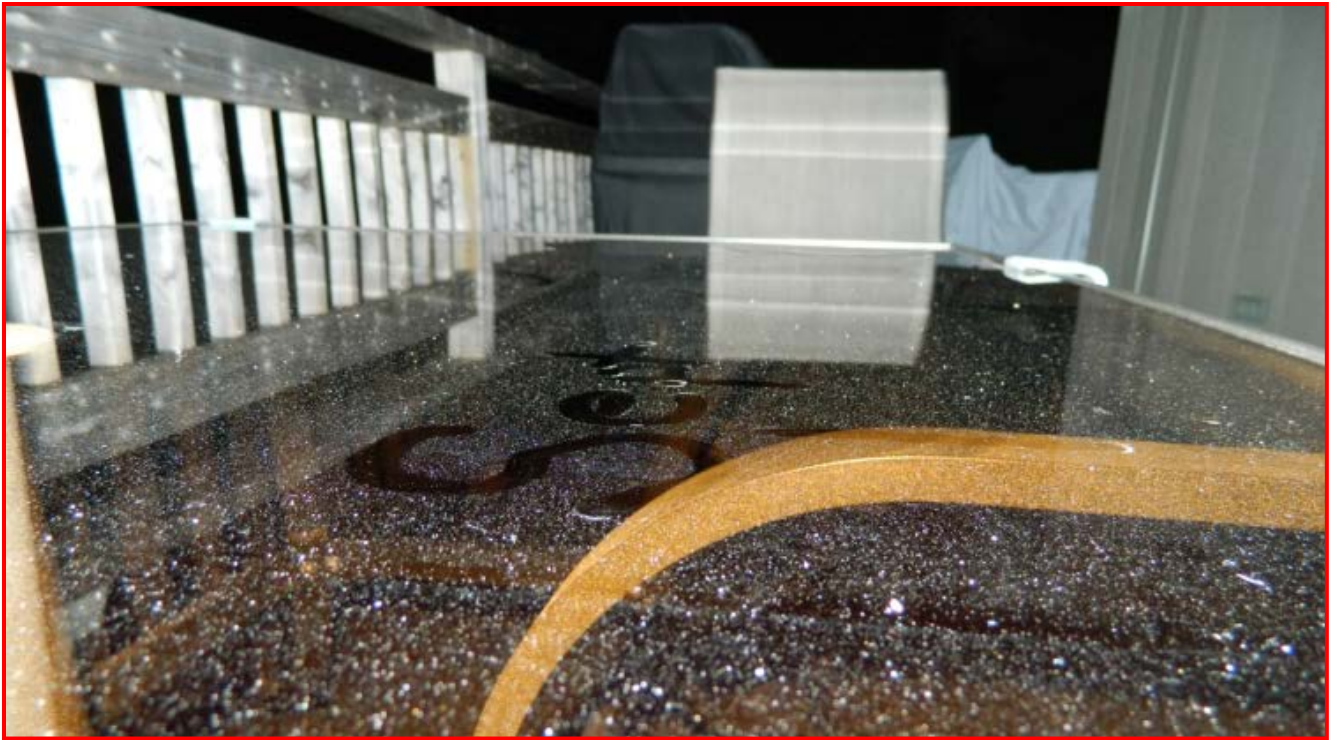
Figure 16: September 1 complaint photo

Complaints of soiling have been registered for virtually every day of September 2012. Photographs from these complaints show various levels of impact, some much more severe than others. It must be noted that the Schedule 2 dustfall standard is quite stringent. It can be violated with loadings that are difficult to see with the unaided eye. The question of adverse effect versus violation must be considered. It is possible to violate the standard and not cause an adverse effect. The violations described are of sufficient quantity, frequency, and extent that adverse effects are occurring. Visual observations such as those presented next demonstrate these violations.

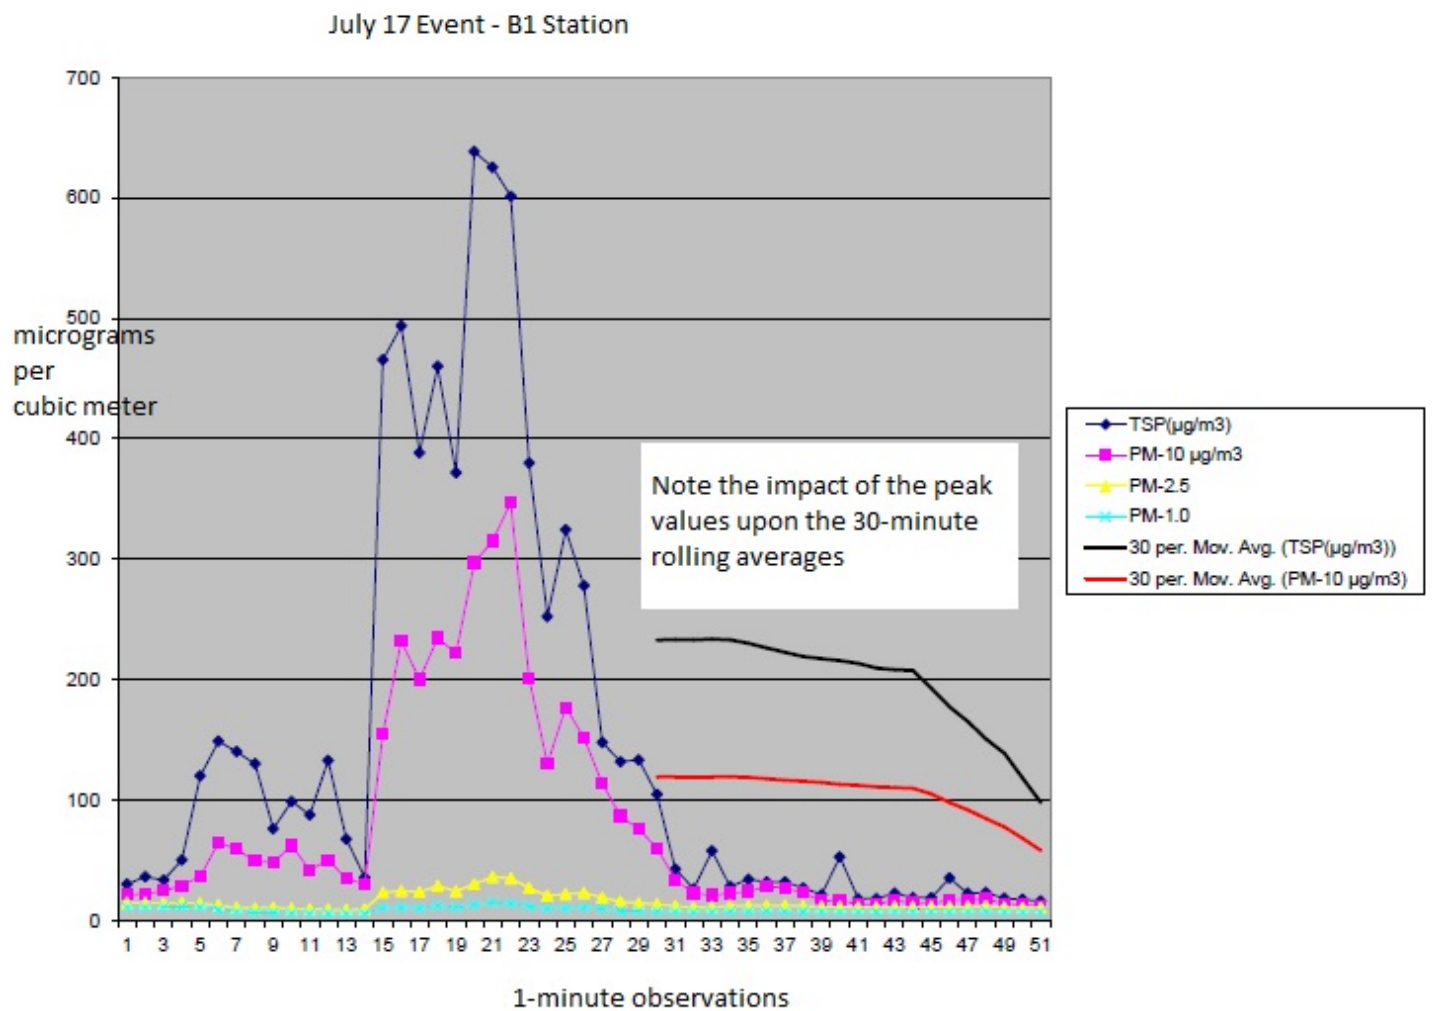
Figure 31: Peak to Mean Effects

The episode depicted in Figure 31 demonstrates a violation of the Schedule 2 standard for TSP. It is not actionable because the Unimin facility has been granted a “regulatory speed-up” which shifts their compliance target to Schedule 3.

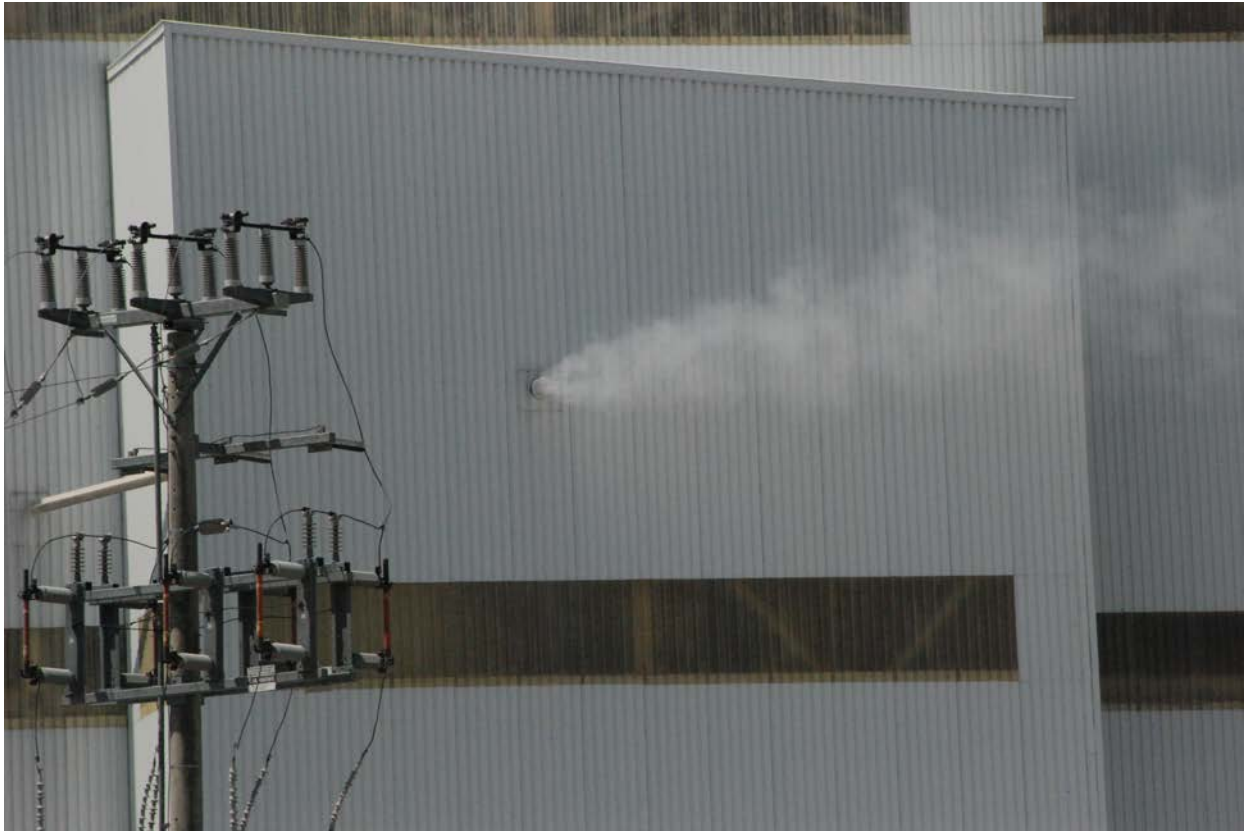
Figure 2 Particulate Discharging from side of plant wall at Blue Mountain Mine

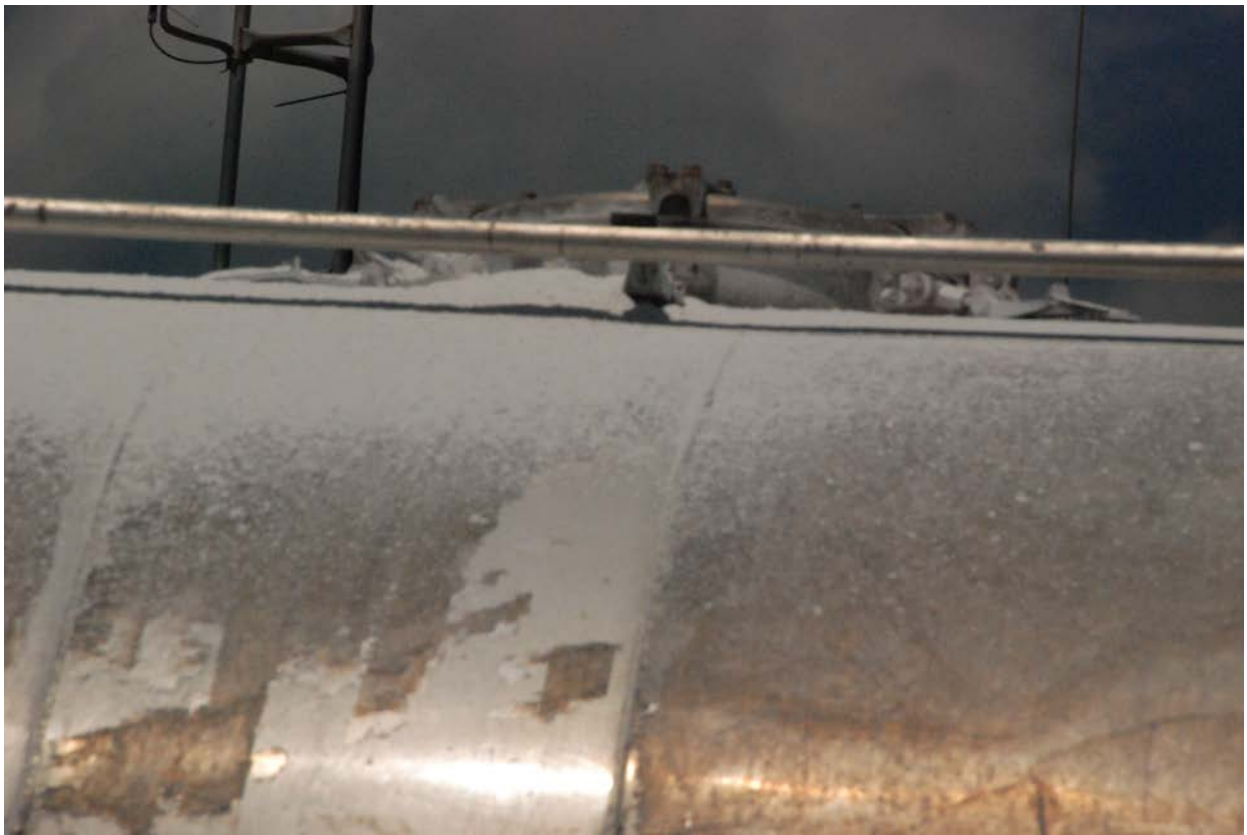
Figure 3 Transport truck with Product Spilt from Loading, Leaving Blue Mountain Mine

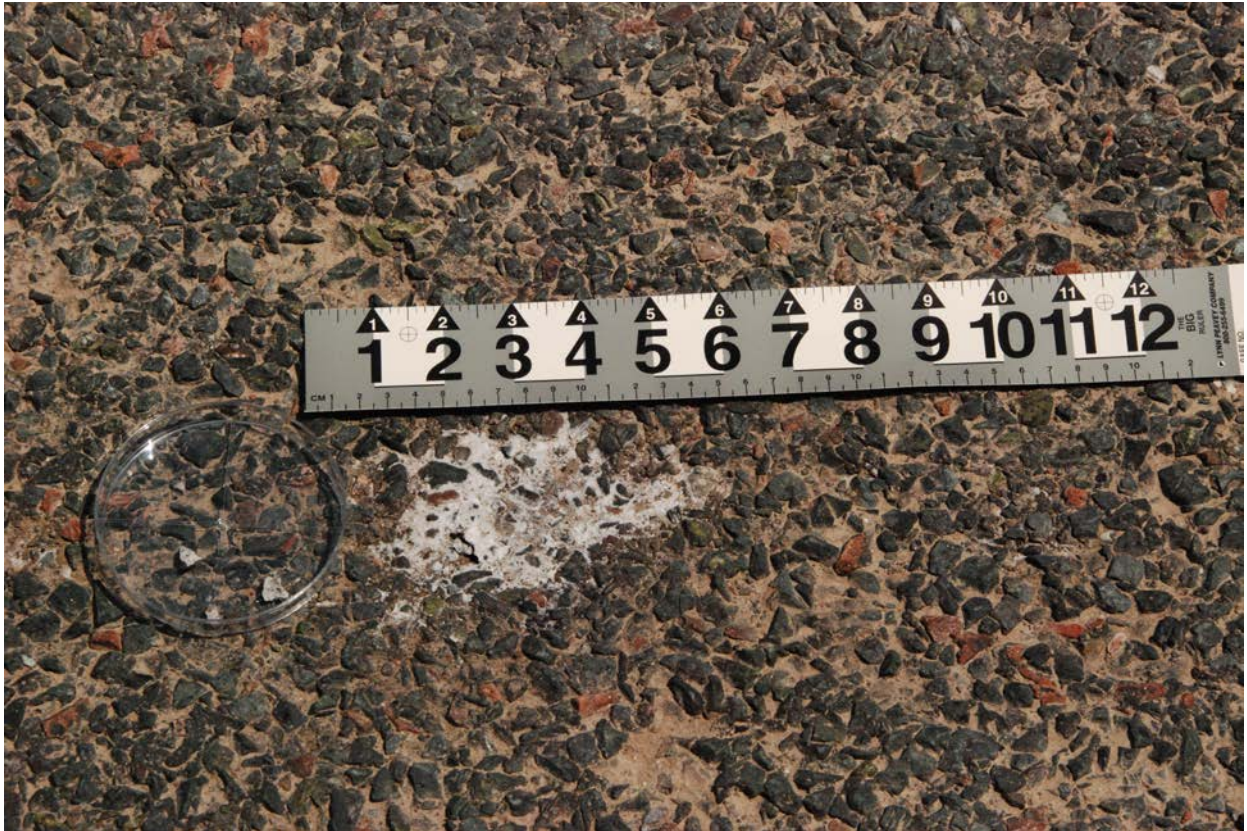
Figure 4 **White Material on Highway 46**

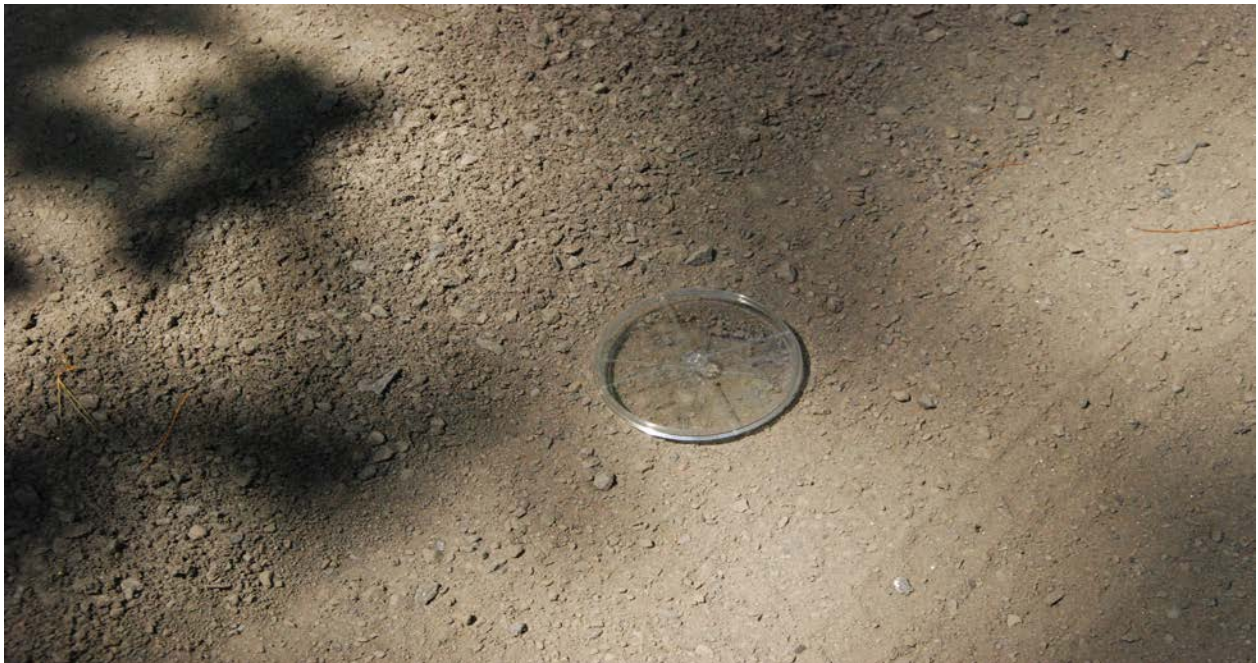
Figure 5 **Road Material used on Fire Route 82**

The company's reference material was sent to the Ministry Lab for particle size distribution analysis. See Appendix B for laboratory analysis. The size distribution results will be further discussed in Mike Ladouceurs' report. The instrument filters were sent for microscopic analysis. The white material collected on Highway 46 was analyzed using microscopy and x-ray fraction analysis, see Figure 4. The gravel collected had just been spread on the road and had not yet been compacted by vehicles, see Figure 5. The results for all swab samples can be found in Appendix

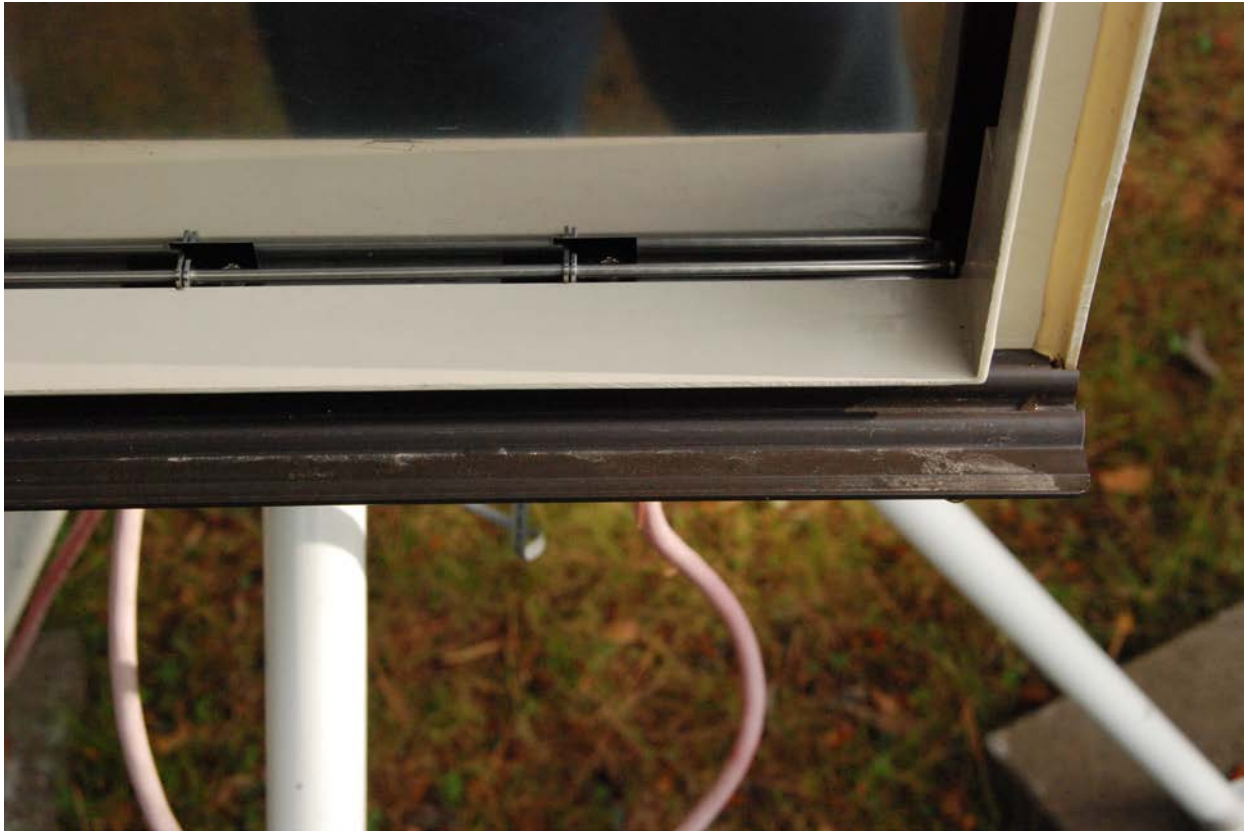
Figure 6 GRIMM located at Fire Route 98

Photographs of the GRIMM instrument lip showed particulate deposits between site visits. See Figures 6 to 9 for examples. Figure 6 is from Fire Route 98, taken on July 31. This is 3 weeks of deposition for this site. A swab sample of particulate off the instrument shelter and inside the instrument case showed the same compositions as the reference material. The residents reported they had seen a dust cloud across Kasshabog Lake on July 17, 2012. Figures 7 to 9 were taken from Fire Route 82. Figure 7 is approximately 3 1/2 weeks exposure, figure 8, 2 1/2 weeks exposure and figure 9, 2 weeks of accumulate deposition. These photographs show the deposition occurring between three consecutive visits from August 21st to October 16, 2012.
